E: SHIFTING PROBLEMS ON ALL NEW GENERATION MODELS

RE: BROKEN CASES ON NEW MAGNESIUM ENGINES

7/15/74
SPECIAL DEALER AND
SERVICE BULLETIN

SPECIAL DEALER
NEWS LETTER
7/18/74

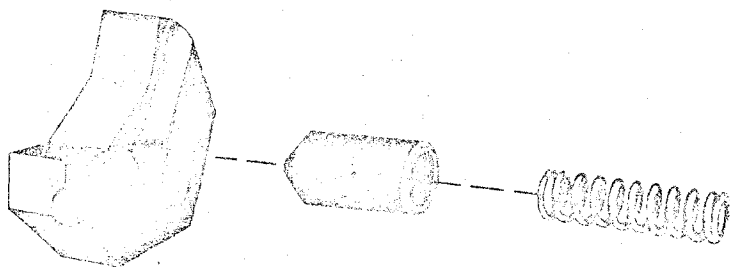
Some new bikes, when assembled out of the crate and run for the first time, may experience shifting trouble. The symptom to look for is the shifting lever sticking in either the up or down position. The shift lever won't self-return to the normal position by itself, but should return manually with pressure.

If the problem doesn't correct itself within a few hours of riding, the transmission will have to be dismantled for repair. The problem will be found at the internal detent pin, which operates against the recess in the shifting pawl (shown below).

You will find the detent pin to have a sharp/flat edge where the detent spring fits in. This edge is catching on the spring and causing the shifting to hang up.

The problem can be corrected by replacing the detent pin with one that has a beveled edge, or putting a beveled edge on the existing pin. This can be easily accomplished with a drill bit or a porting stone.

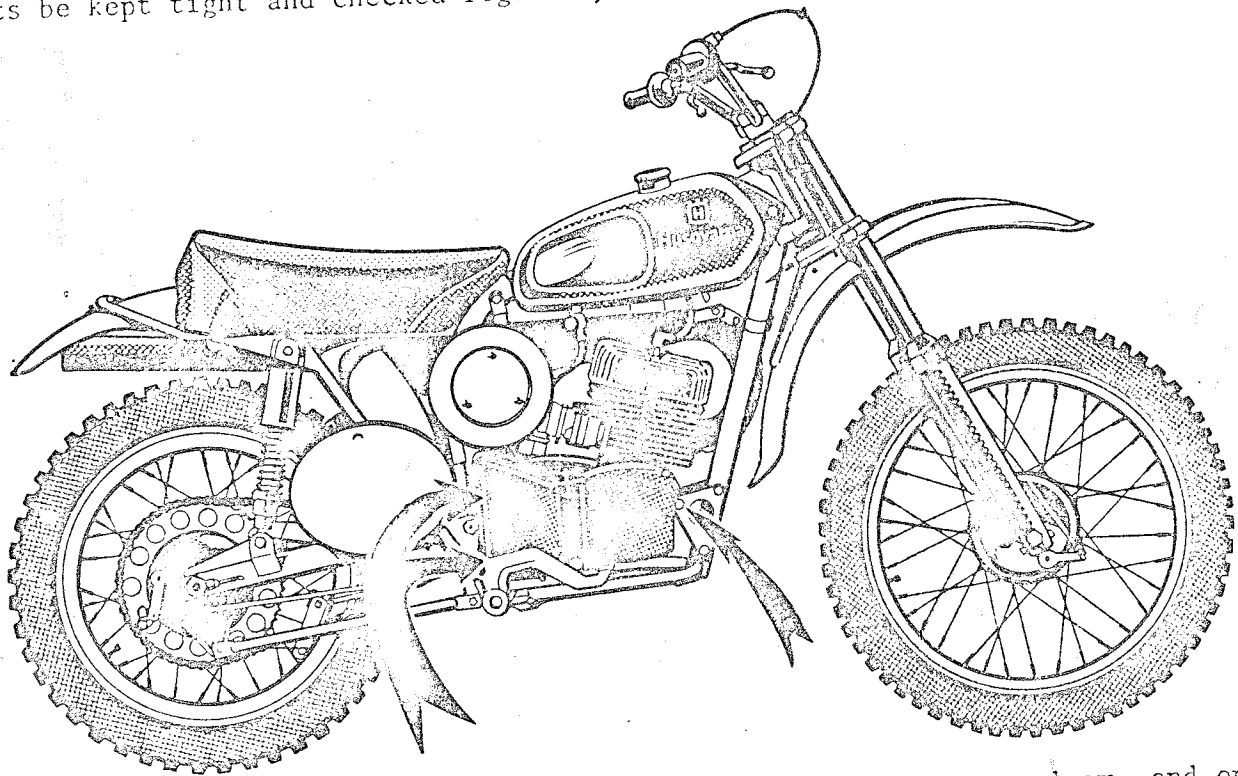
There have been a few instances of cases breaking on the new magnesium engines at the motor mounts. The front engine mount is particularly vulnerable to breaking first. The only reason that these engine cases have broken though, is that the mounting bolts to the frame were allowed to come loose and the engine allowed to vibrate in the frame. It is very important that each of the (3) three engine mounts be kept tight and checked regularly.

Two of the engine mounts are located at the rear of the engine, as shown, and one at the front. The threads on each engine mount bolt should be Loctite coated, and then the lock nuts torqued down to 60 ft.lbs. on the 10mm upper rear engine mount bolt and 25 ft.lbs. on the 8mm lower rear and the front engine mount bolts.

In the event that the engine case doesn't fit tightly in the frame at the rear section, washers should be used to secure the engine tightly in the frame mounts before the bolts are slipped in and the lock nuts tightened.

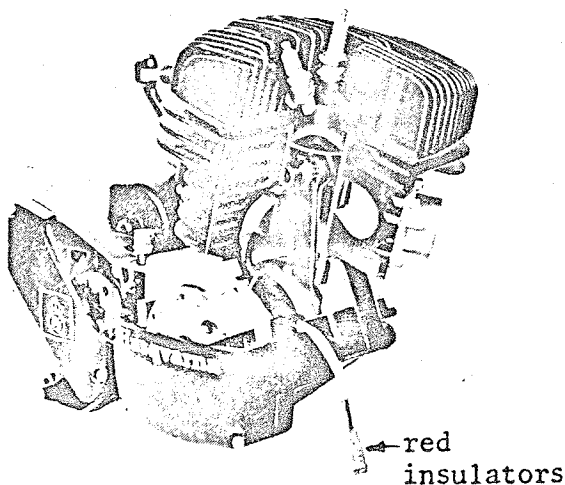
Motorcycles will fail to produce any ignition spark if a new style Motoplat magneto unit with red insulator grommets is used to replace an old style Motoplat magneto unit.

The new style red marked units have the diode adapted to the high tension coil from the magneto assembly to allow better heat dissipation.

When ordering these parts, be sure to state on the order form whether you need the old style or the new style (red).

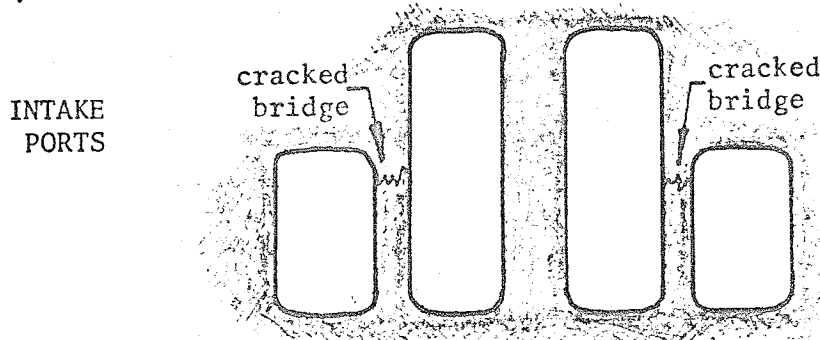
There have been a few instances of the intake port bridges breaking or cracking in the cylinders of the 250 magnesium engines. The bridge usually stays attached to the liner, so it doesn't fall into the crankcase and cause damage, but the cylinder and the piston assembly have to be replaced when the cracked liner is discovered.

The cracked intake port bridge is caused by running the engine with excessive piston to cylinder wall clearance, brought about by wear.

The best solution is to prevent the bridges from cracking by not allowing the piston to cylinder wall clearance to get too loose. The piston to cylinder wall clearance should not be allowed to exceed .007-8 inches. Measurements should be made at the front and rear of the piston skirt and at the middle of the cylinder bore. In bikes heavily used for competition, this clearance should be checked periodically.

If pistons are replaced periodically before wear becomes excessive, the same bore can be used two or three times before the cylinder needs to be rebored. Also, performance will remain strong.

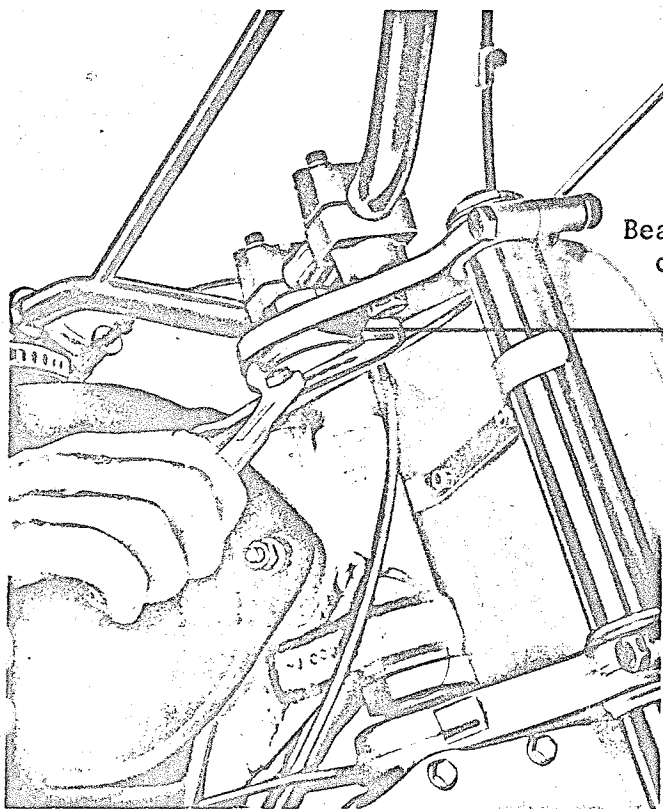
Bikes which may have had their steering heads set up or maintained improperly will experience failure of the caged ball bearings and the bearing seats. The cause is lack of grease and/or allowing the bearing shell cap to become too loose.

To correct the problem, first replace the caged ball bearings if damaged and the bearing seats. Looseness will have dented the bearing seats and smashed the caged ball bearings.

If you have difficulty in tightening the bearing shell cap with channel lock pliers as shown, you can grind it to accept special steering head wrenches which are available.

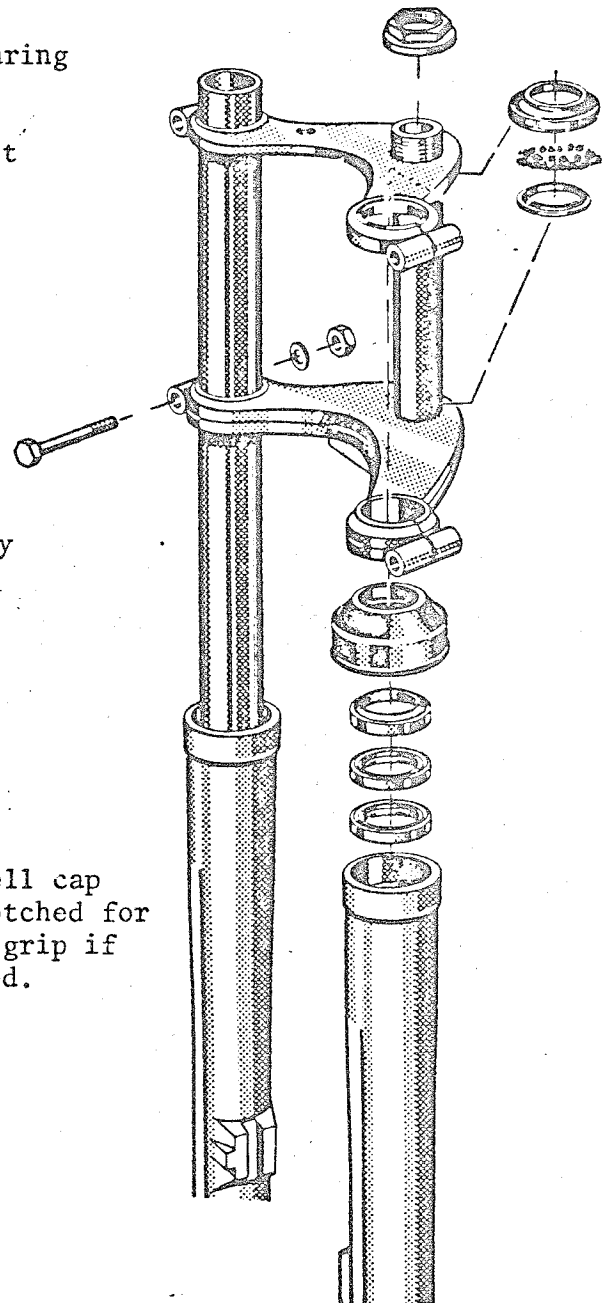
Bearing shell cap
can be notched for
better grip if
needed.

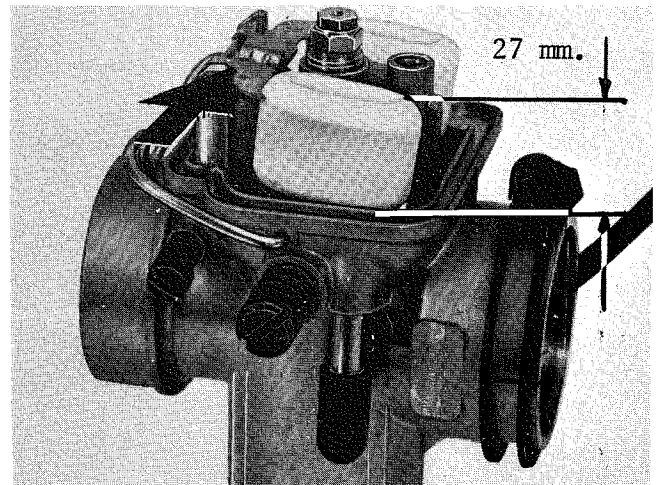
We have found that the float level on Bing carburetor for 250 GP and 360 GP vary, which makes it difficult to get the jetting proper for mid-range performance. We recommend that you check the float level setting before any jet changing is done.

When you have the carburetor off the bike, turn the carburetor upside down, take the float bowl off and check the distance between the top of the float and gasket where the float bowl seats. This distance should be 27 mm. (see photo) when the plate on the float touches the float needle.

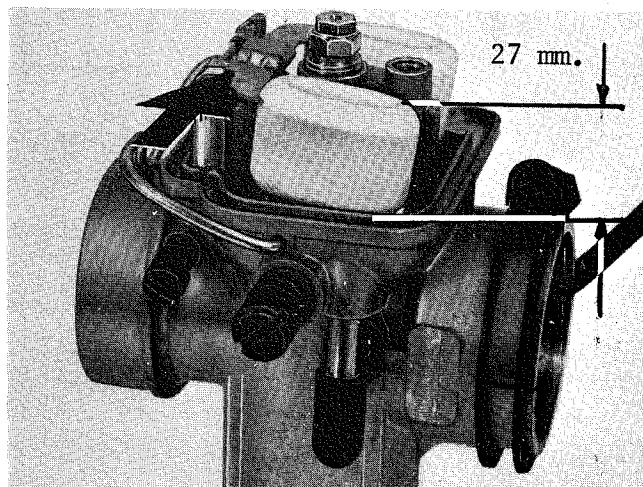
We have found that the float level on Bing carburetor for 250 GP and 360 GP vary, which makes it difficult to get the jetting proper for mid-range performance. We recommend that you check the float level setting before any jet changing is done.

When you have the carburetor off the bike, turn the carburetor upside down, take the float bowl off and check the distance between the top of the float and gasket where the float bowl seats. This distance should be 27 mm. (see photo) when the plate on the float touches the float needle.

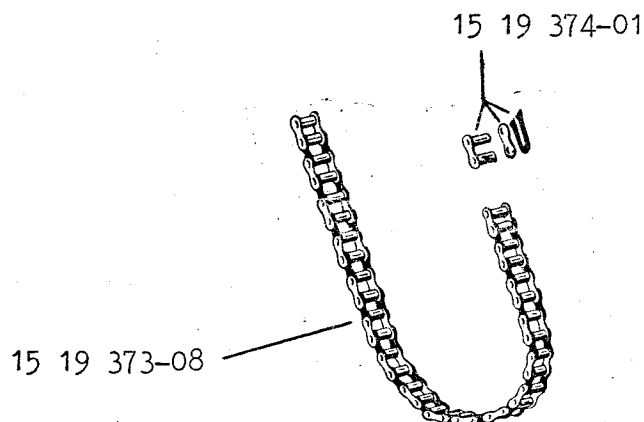
On pages 17 in spare parts manuals 250 CR, 10 12 061-96 and 390 CR, 10 12 062-96 have a wrong number been printed on detail 34 masterlink and detail 35 chain.

Pos. 34 masterlink shall be number	15 19 374 -01
Pos. 35 chain shall be number	15 19 373-08

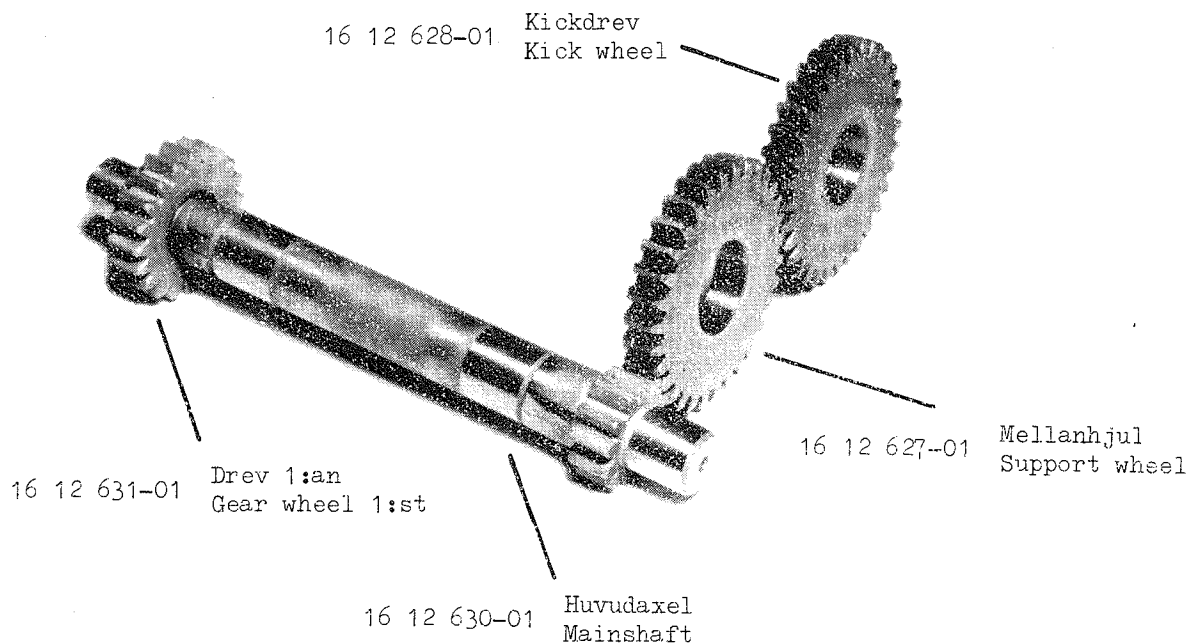
As to kick-starter function, you cannot only change the mainshaft without changing the support wheel and the kick-wheel, because we have introduced a new tooth form.

Part number on this kit: 16 19 806-01. Also see fig. below.
