SERVICE BULLETIN

This is a revised and up to date index of section 8 service bulletins. Please file in the beginning of section 8 of your service manual for easy reference to applicable bulletins. Also enclosed are additional index sheets to keep the index up to date. This index will become effective March 1, 1984.

INDEX OF SERVICE BULLETINS

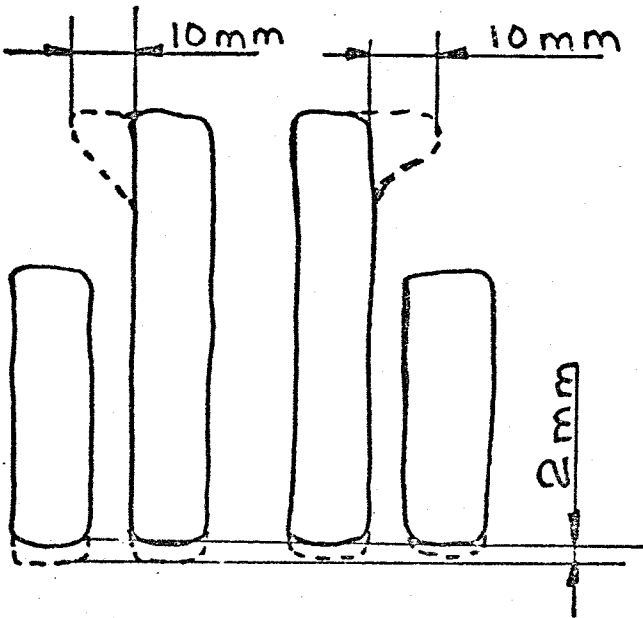
lower the intake ports 2mm each and widen the two boost ports 10mm each. It is very important that the angle at top of the ports remain the same when widening.

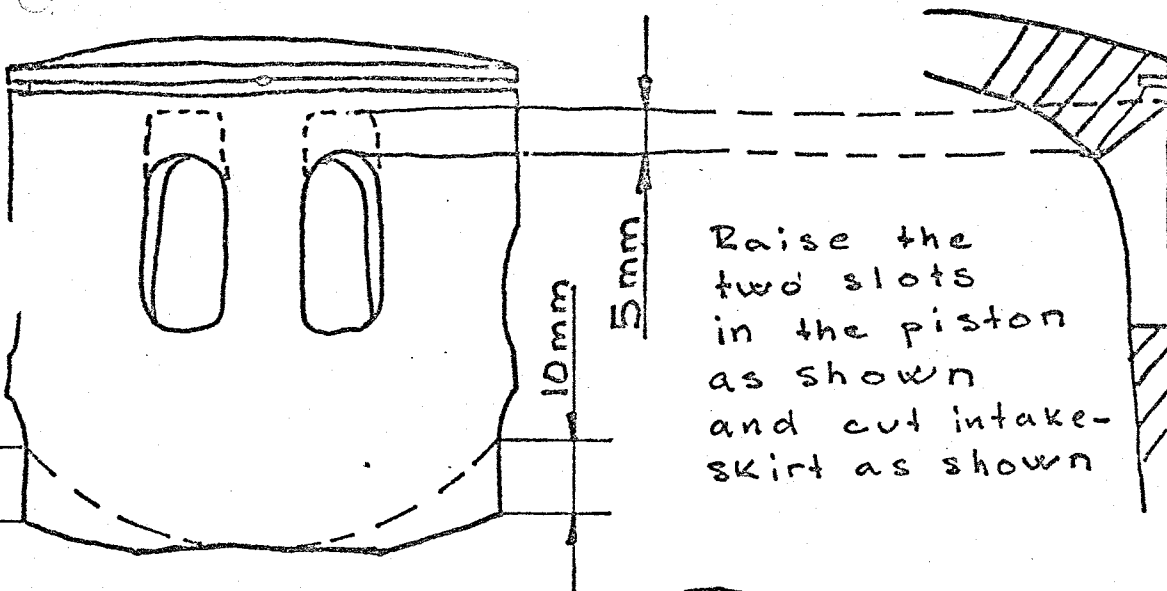
Raise the two slots in the piston as shown and cut intake-skirt as shown

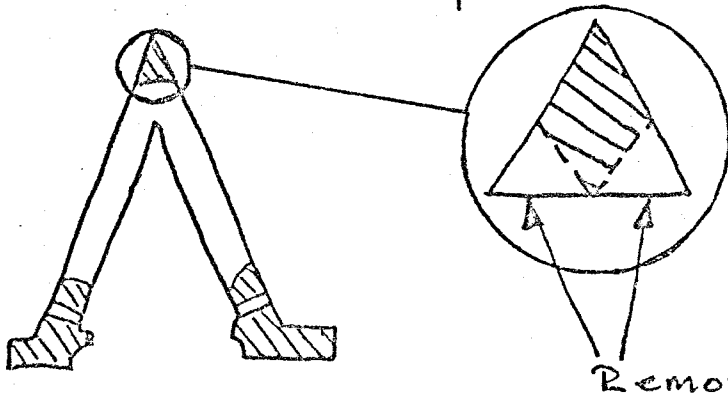
modify the reed valve cone as shown.

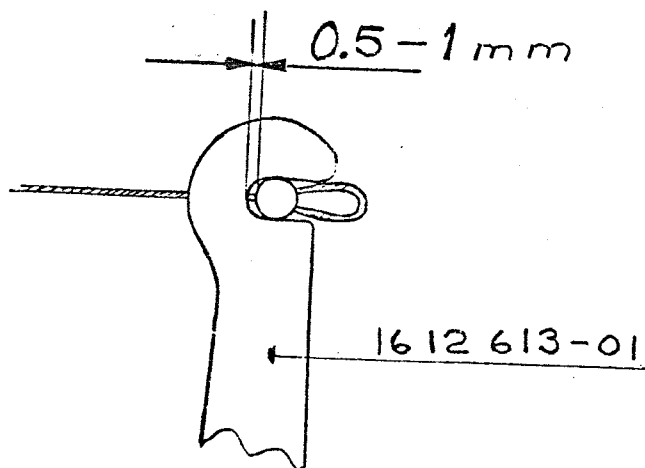
Please adjust engagement lever as shown. If the play between lever 16 12 613-01 and the cable nipple is excessive the engine will not disengage properly.

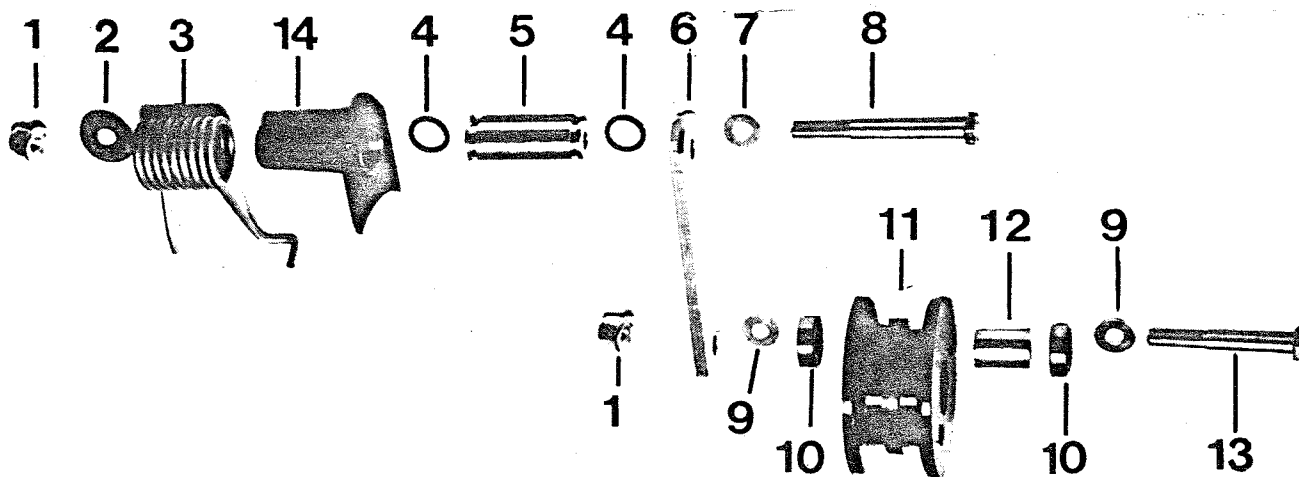
Proper operation of the spring tensioner requires special service requirements. At each time of service, the bearings in the tensioner wheels need to be inspected. Remove the bearings and check for dirt that may be jammed between the aluminum arm (Item 6) and the bearings (Item 10).

The aluminum bushing (Item 5) must also be inspected. Remove it from the swingarm, clean any dirt that may have accumulated and sand down any score marks. Install the bushing after thoroughly greasing it.

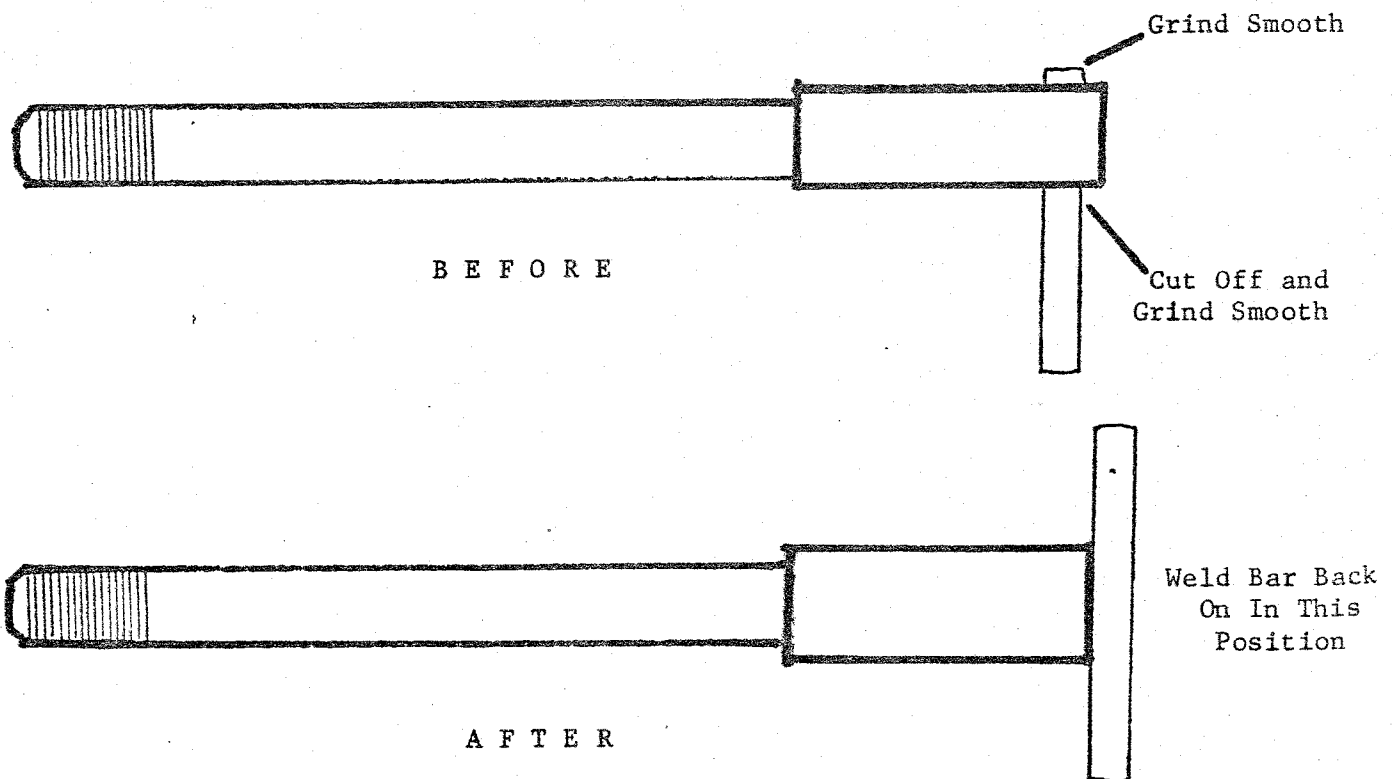
The object is to eliminate the wheel spacer that is used when the speedometer drive is not used. This will prevent the spacer from being lost in the event the front wheel is removed on the trail. Relocating the axle pull bar allows the axle end to be drawn further into the fork leg, eliminating the need for a spacer.

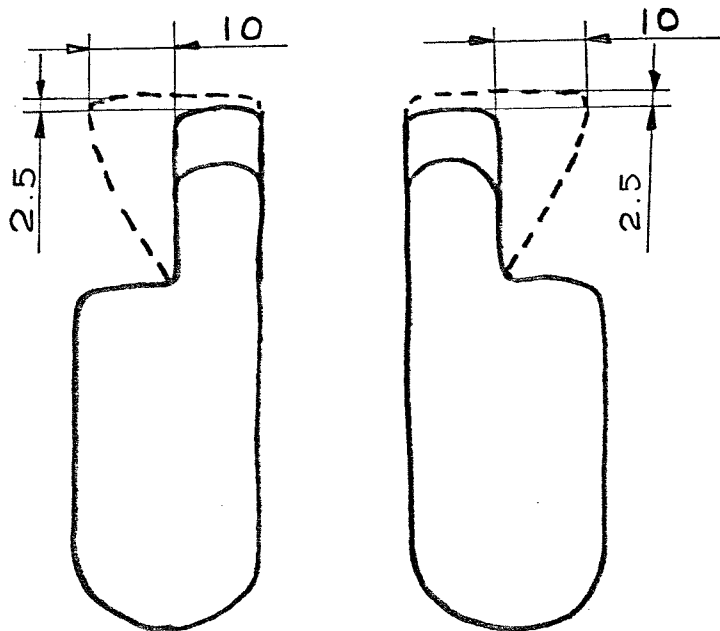
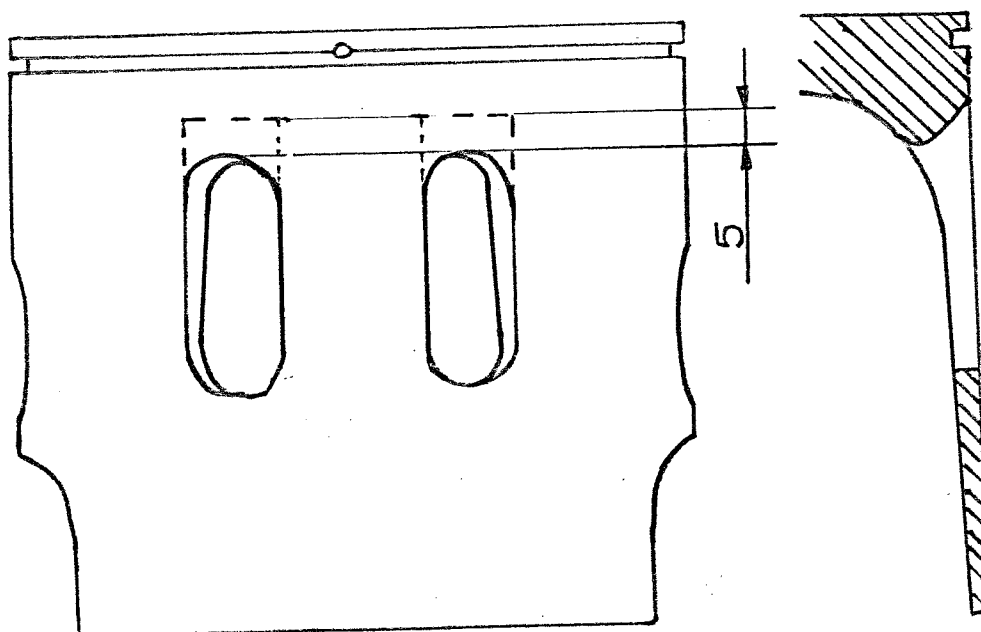
Widen the two boost ports 10mm as shown, also raise them to the same height as the two transfer ports (about 2.5mm). It is important that the boost port angle remains the same.

Widen the piston slots 1.5mm each and raise them 5mm, as the left figure shows. The figure on the right shows a cut through one of the piston slots and the approximate angle of the port when raised.

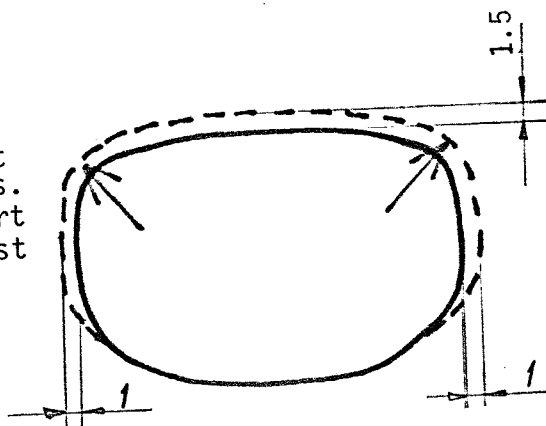
Raise the exhaust port 1.5mm and widen it 1mm on each side as the dotted line shows. Be careful with the upper edge on the port especially where the arrows show. It must be a smooth radius between the top edge and the side edges.

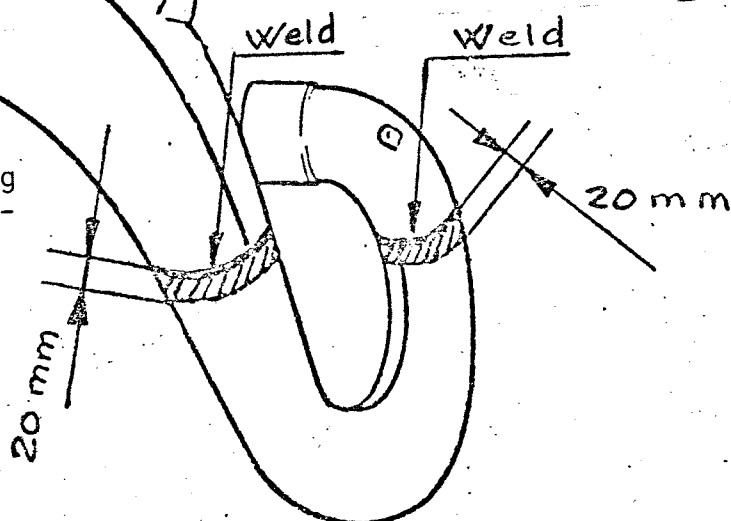
Shorten the exhaust pipe, by cutting 20mm (3/4 in.) off, below the existing welds as figure shows. Thereby shortening the pipe a total of 40 mm.

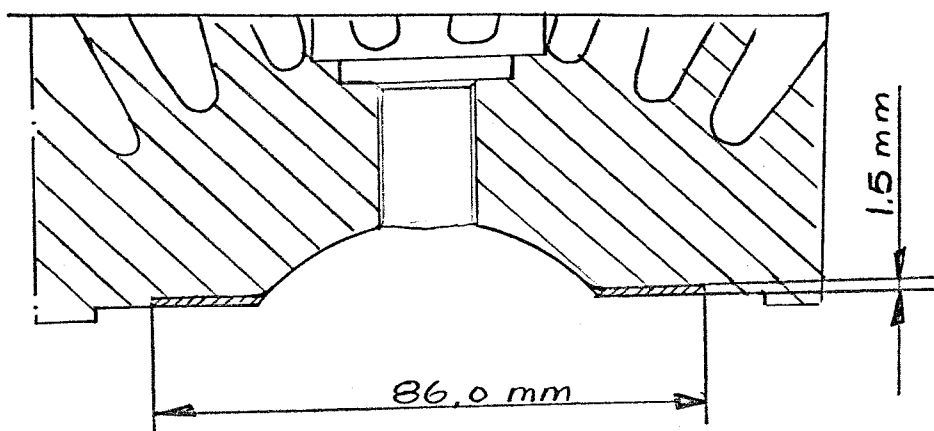
This figure shows a cut straight through the center of the cylinder head showing the combustion chamber. With an increase of cylinder volume it is also necessary to increase the volume of the combustion chamber in order to maintain the same compression ratio as before. Therefore raise the squishband 1.5mm on a 86mm diameter (the sealing surface between the cylinder and head is not touched).

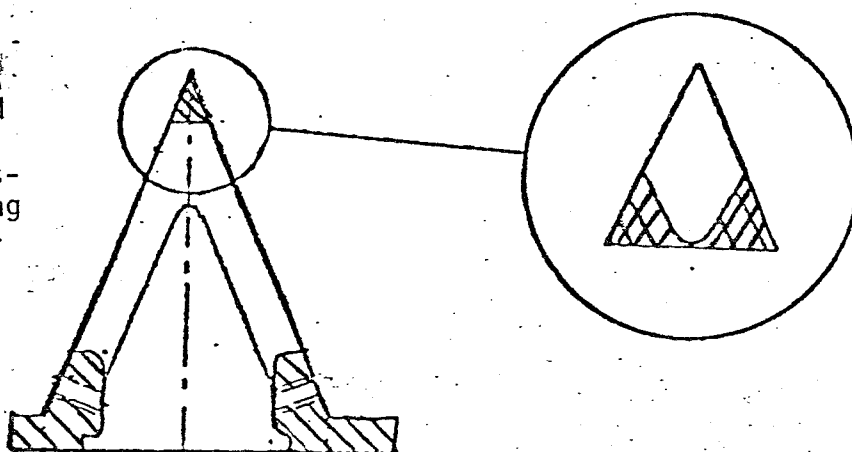
Sharpen the front piece of the reed valve holders (1610 357-01) Remove all the (in the enlargement), cross-marked material. When re-assembling the reedvalves, make sure the sealing surface is minimum 1mm all around the reedvalve holder.

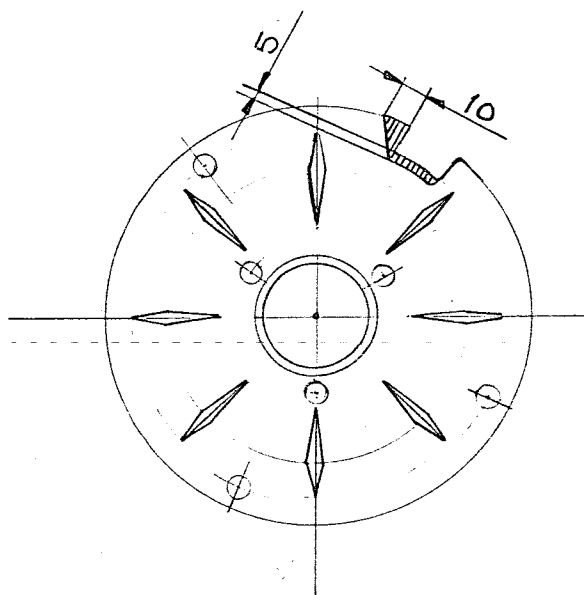
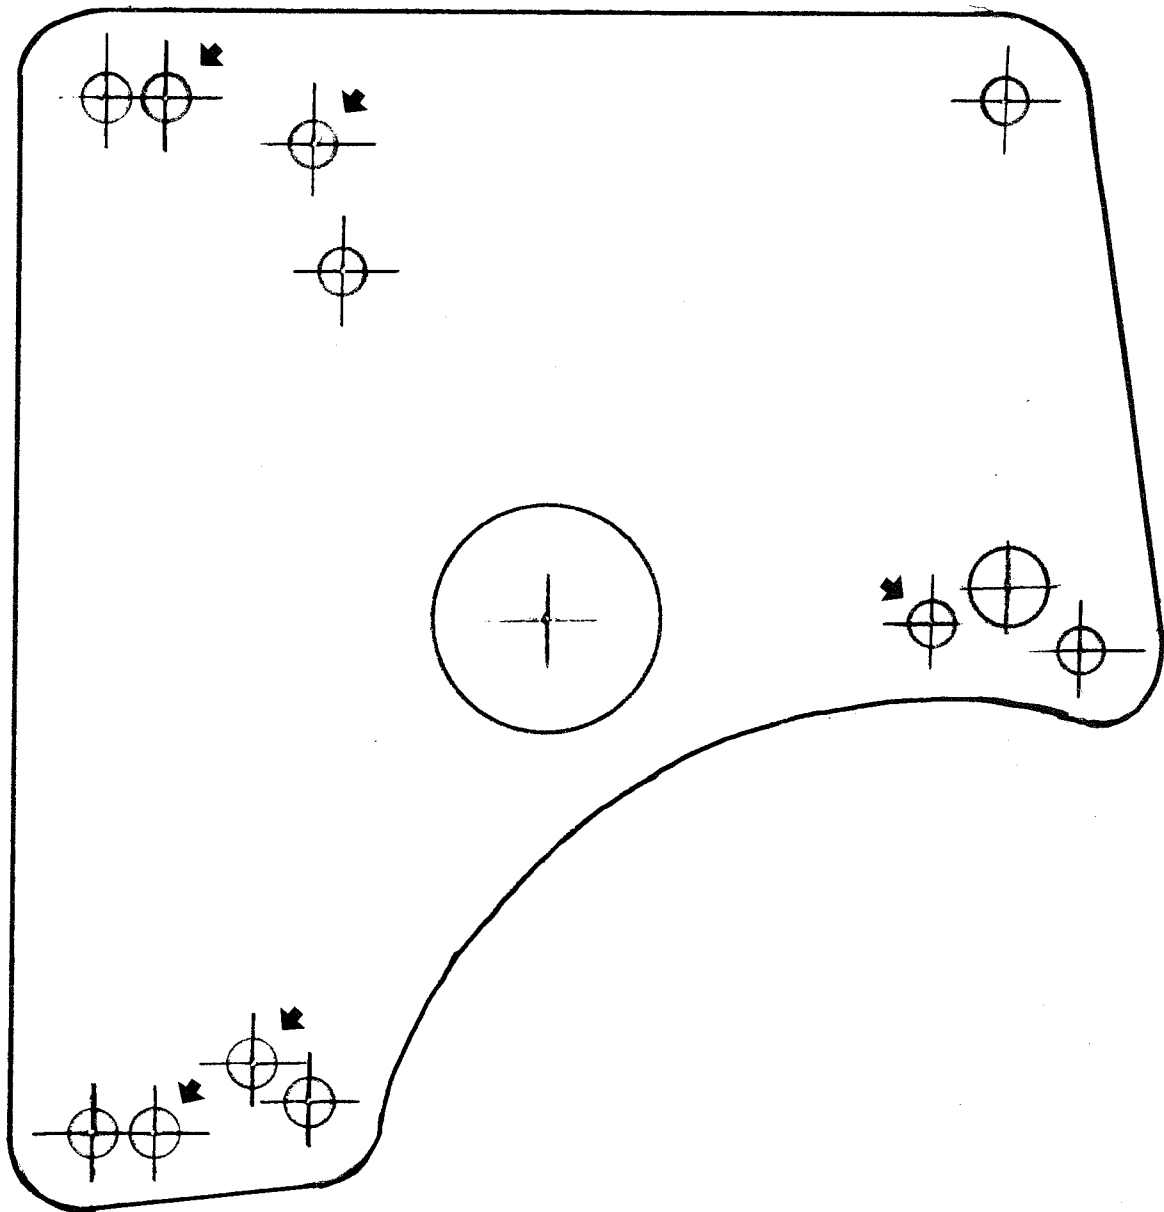
There is a sharp bend in the wires coming from the ignition stator. To eliminate the risk of the wires being exposed at the bend, an increase in width and depth of the backing plate cutaway can be made.

Fig. on right shows
ignition backing plate.
Modify as shown
(Measurements in mm.)

After removing the ignition rotor and stator the backing plate can now be removed. The stator backing plate can be modified as shown in the following figure diagram. This can be easily done with a round file. When reassembling, re-torque the flywheel nut to no more than 50 ft., lbs.

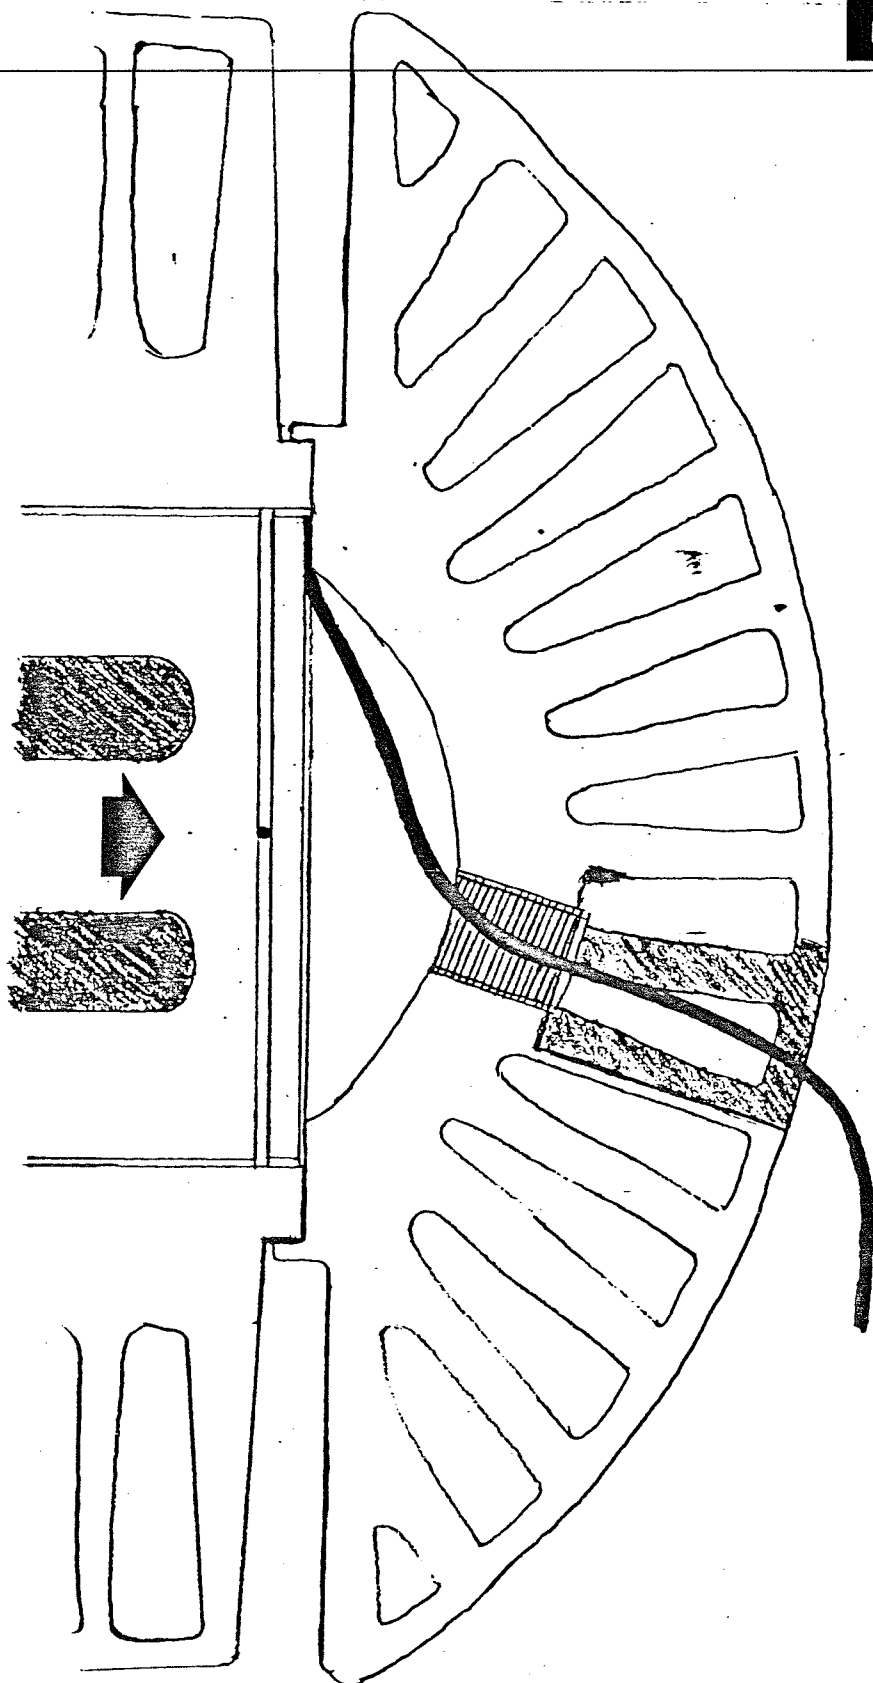
Measure the amount of clearance by inserting some solder into the spark plug hole and bringing the piston to top dead center. (see drawing) If the measured clearance is less than 1.0 mm it will be necessary to have the head machined. Machine the cylinder head in a lathe, removing metal only at the point where the piston could contact the head. Remove enough metal so that a minimum of 1.0 mm is reached between the cylinder head and piston at top dead center.

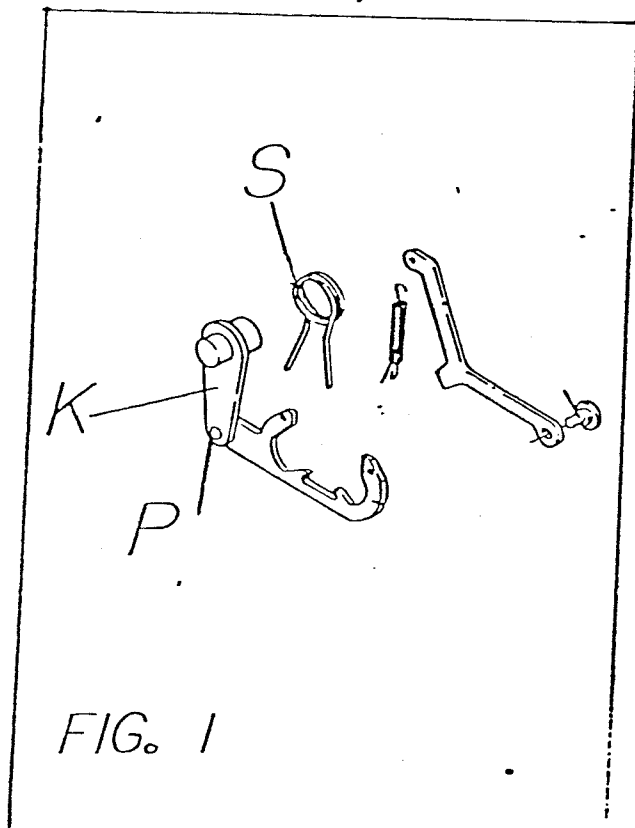
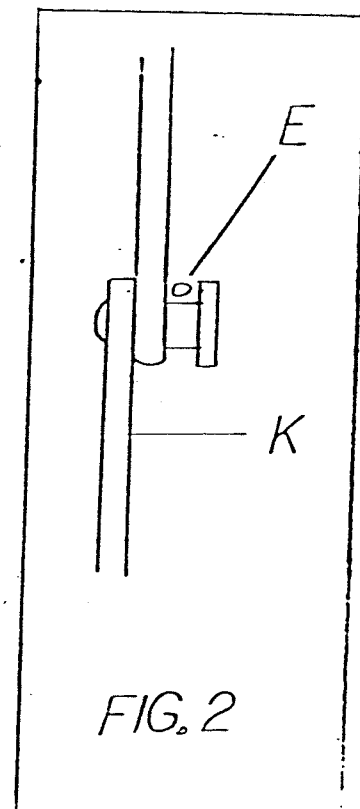
The possibility exists for the return spring (fig. 1, letter S) to work its way up the locating pin in the primary cover and become unhooked from the kicker (fig. 1 & 2, letter K). When this happens the shift lever will not change the gears correctly or return to its rest position. If you determine that this has happened, the following needs to be checked:

1. Lay motorcycle on right side or drain oil and leave motorcycle standing.
2. Remove primary cover, clutch assembly and kicker (fig. 1 & 2, letter K).
3. (Fig. 2, letter E) shows the correct position of the open arms of return spring (fig. 1, letter S) in its unsprung state. The open ends of this return spring should freely return into its groove (see fig. w, letter E). If the spring arms seem to not return to this position, then the spring will try to work its way out of (fig. 2, letter E) when the shifter is worked.
4. To repair, it may be a matter of simply turning the spring around and see how it fits or bend the open ends of the spring so the spring ends fit into (fig. 2, letter E) kicker.
5. Replace the kicker, clutch assembly, primary cover and re-fill with oil if necessary.

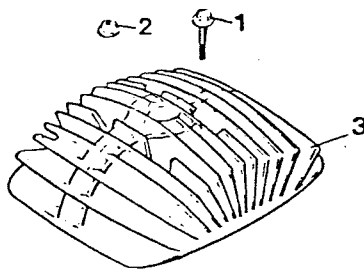
It's been found that the above models can develop a leak at the cylinder head to cylinder seal. Not all bikes will do this. If this does occur, you will notice that there is an unusual amount of oil on top of the cylinder on the exhaust or intake side or both. Remember there will always be small amount of oil due to expansion of these parts as the engine heats up and cools down.

The reason this leaking can occur is the bolts, (fig. 1) in the drawing, will bottom out in the hole before they tighten on the head. To repair, remove cylinder head and cylinder. Lap the head to the cylinder and re-install using bolts that are approximately 2-3mm shorter.

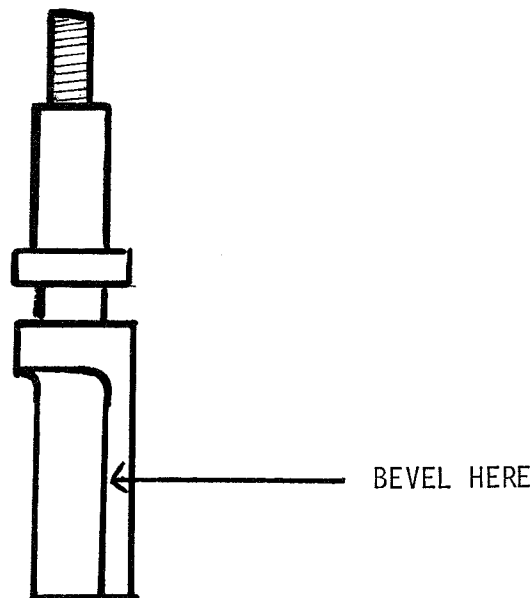
FIGURE A

1. Unhook the clutch cable from the lever that sits atop the engine cases.
2. Remove the set screw that locates the pictured (fig. A) clutch release shaft and the shaft itself. A prying instrument will probably be needed.
3. Increase the radius slightly at the edge indicated by an arrow. This may be done with emery paper and remember only a little increase in the radius is enough.
4. Clean thoroughly and replace. Install set screw and cable. Clicking noise should now be gone.

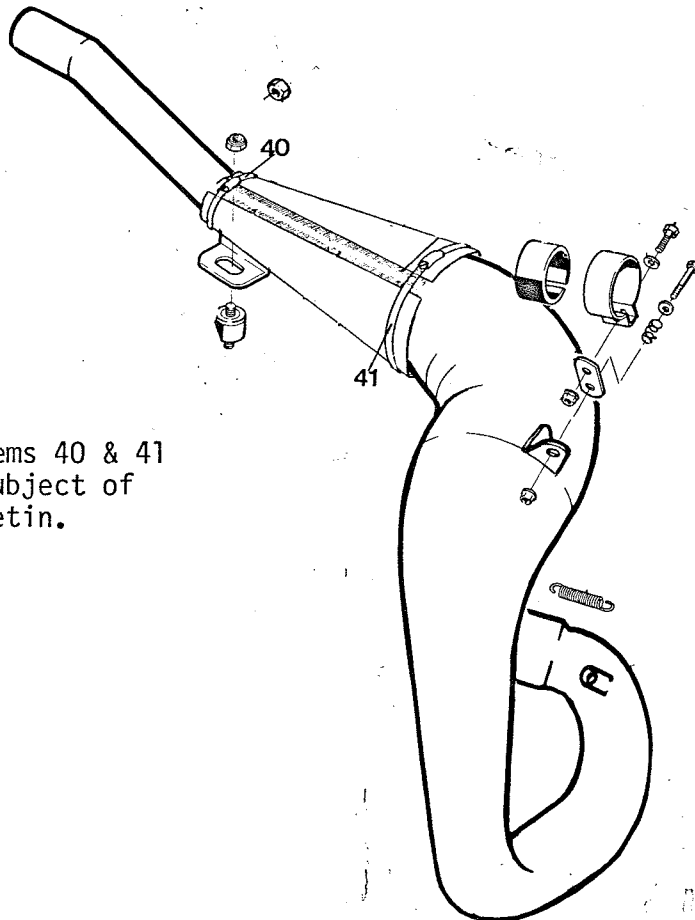
It is possible that the clamps that hold the doubled walls on the exhaust pipes of the 1983 models that are equipped with this feature, have been installed with the tightening screws on the top of the exhaust pipe. We have found that the clamps should be installed with the tightening screws at the bottom of the exhaust pipe to avoid damaging the gas tank. Please be sure that the clamps are correctly installed during the initial set up of the motorcycle prior to delivery of the motorcycle to the customer.

NOTE: Items 40 & 41
are the subject of
this bulletin.

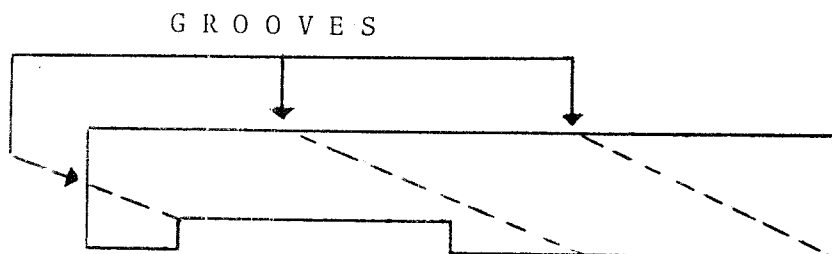
We have found that the grooving of the first gear clutch engagement shoes makes the engagement of first gear much smoother and also lowers the RPM's engagement point. Using a hacksaw, carefully cut 3 grooves at an approximate angle of 60° across the engagement surface of the first gear clutch shoes. The depth of the groove should be approximately 1/16th inch. The grooves should be spaced approximately the same distance apart. Carefully clean all parts before reassembly.

View of engagement face of 1st gear engagement shoe showing approximate location of grooves.

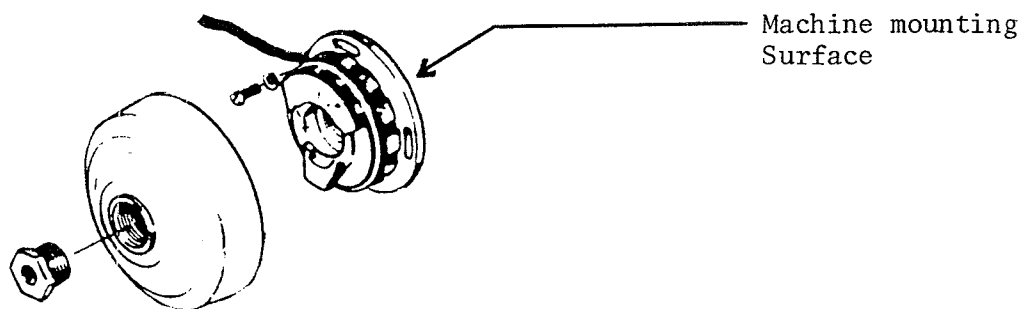
We have been advised by the factory that many of the hard starting, when hot, 4 stroke problems can be relieved; if sufficient air gap is maintained between the components of the 16-15-108-01 flywheel ignition. It is necessary that a 1mm wide air gap exist between the flywheel and stator to allow for heat expansion. To check for this air gap remove the flywheel and apply some plasti-gage or measuring clay around the stator. Reinstall the flywheel and then carefully remove the flywheel again and measure the plasti-gage or measuring clay. If there is less than 1mm of thickness of plasti-gage or measuring clay on any portion of the stator, it will be necessary to remove the stator portion of the ignition from the crankcase, and machine the mounting side of the stator mounting plate to obtain the necessary 1mm of air gap. When machining be careful not to damage the stator or wiring loom. Reinstall the stator and flywheel correctly. Please loctite all mounting screws and reset the timing to the correct specifications.

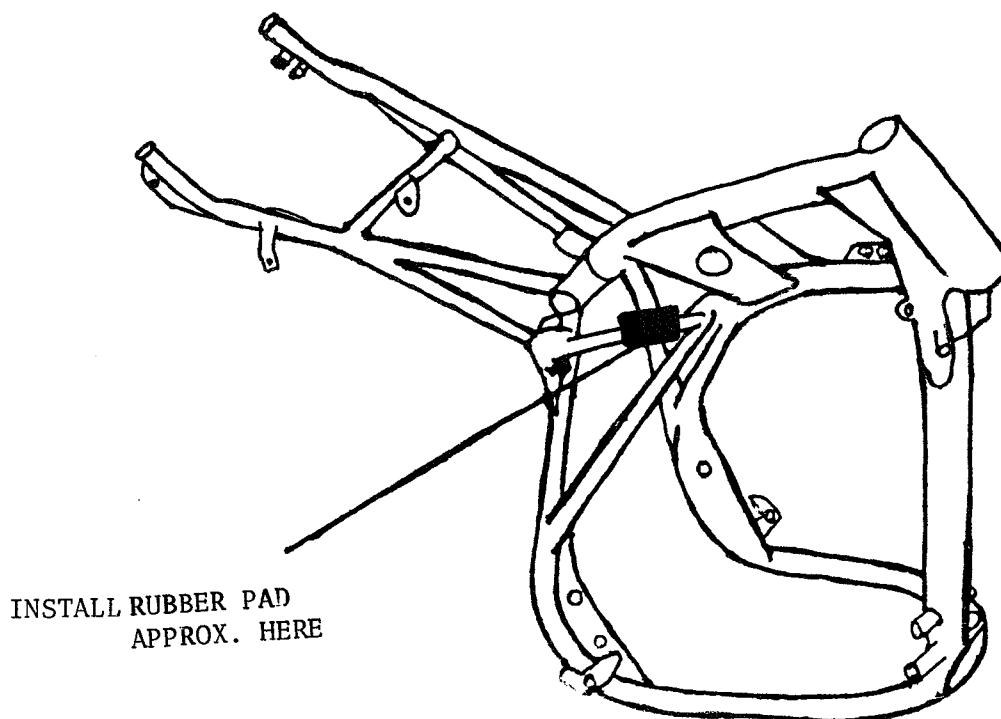
The picture below gives an approximate idea as to where the rubber pad should be placed.

INSTALL RUBBER PAD
APPROX. HERE

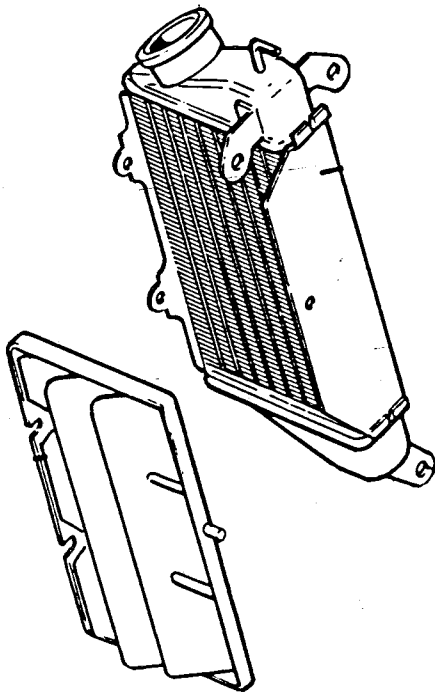
We recommend that all liquid cooled Husqvarna motorcycles be inspected, and if the plastic protection screens or louvers make contact with the radiator, a bead of silicone rubber approximately 1/8 of an inch high should be applied wherever necessary to keep the plastic protection screen or louvers from making contact with the radiator/s.

Apply silicone rubber as needed to prevent plastic louvers or plastic screen rubbing on radiator.

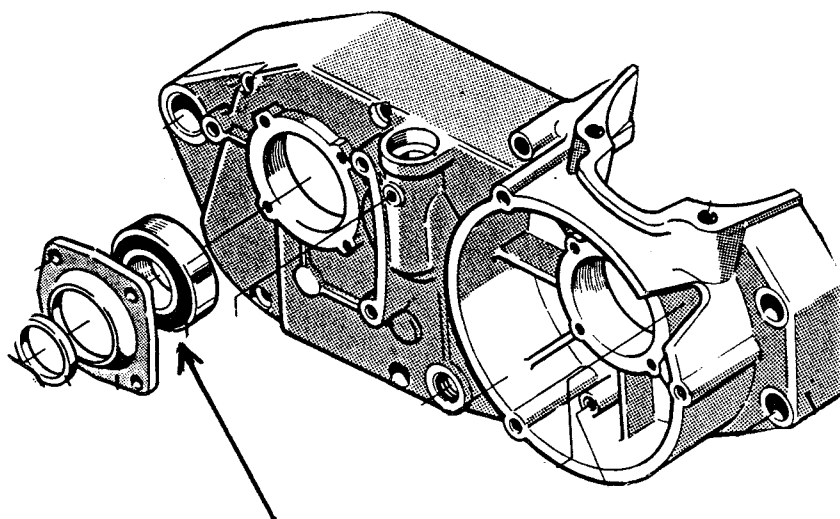
Install gasket here

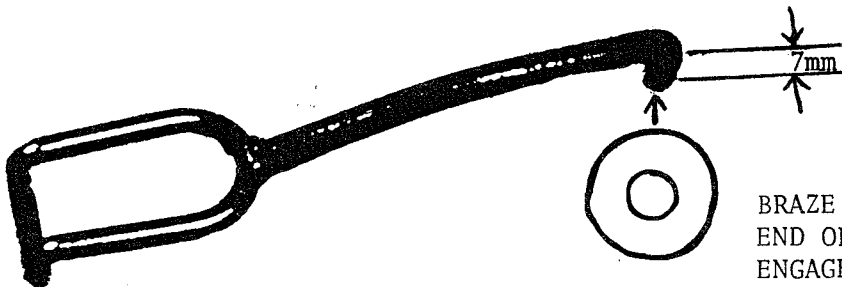
We recommend the brazing of a flat washer on the holding tool engagement end to prevent the holding tool from engaging more than 7mm into the flywheel.

BRAZE FLAT WASHER IN PLACE ON
END OF ENGAGEMENT ARM TO LIMIT
ENGAGEMENT TO 7mm.
