SERVICE BULLETIN

This is a revised and up to date index of section 8 service bulletins. Please file in the beginning of section 8 of your service manual for easy reference to applicable bulletins. Also enclosed are additional index sheets to keep the index up to date. This index will become effective March 1, 1984.

INDEX OF SERVICE BULLETINS

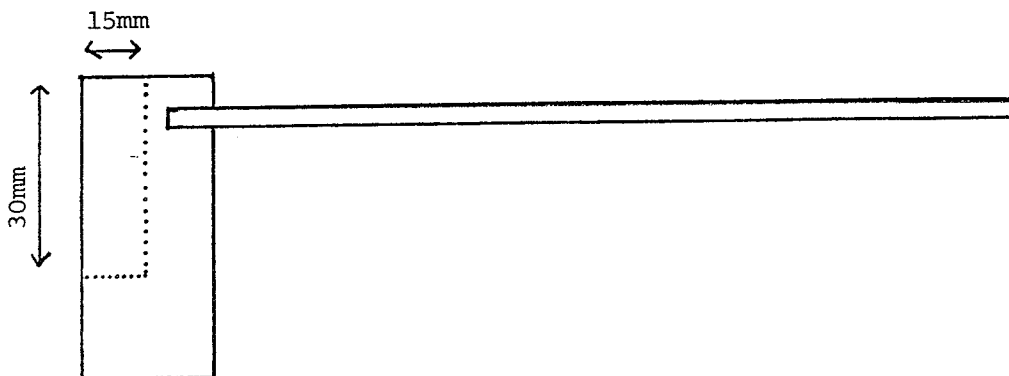
This job can be quite difficult with a hacksaw. The material used to make the wrench is very hard.

Cut the wrench at the dotted line to the dimension indicated. This can most easily be done with a cutting wheel or by putting the wrench to a grinding wheel. NOTE: Always wear eye and hand protection when cutting or grinding with tools.

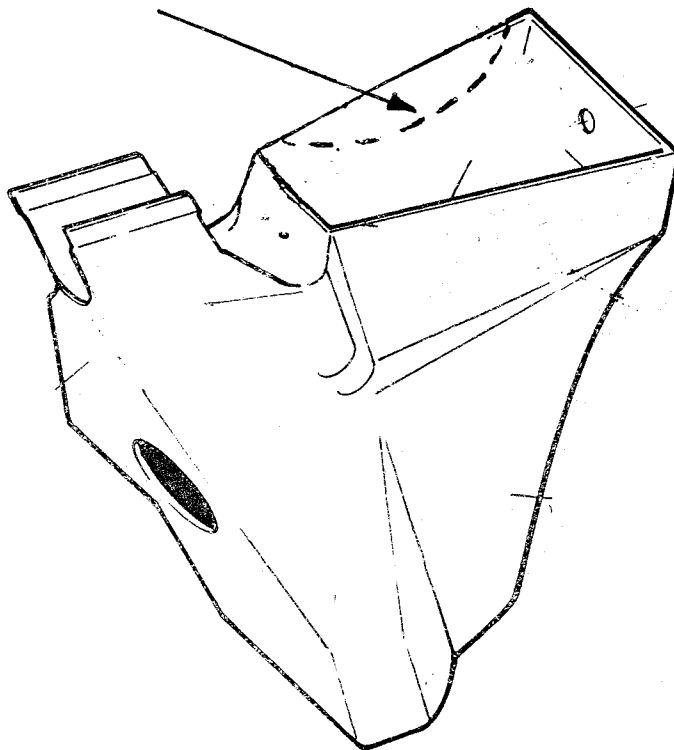
The Factory has discovered that the 1984 250 CR will increase engine performance if the right side of the air filter box is cut down according to the illustration.

We do not recommend that the motorcycle be operated without the right side panel in place if this modification is performed. The right side panel will shield the air filter from direct splash.

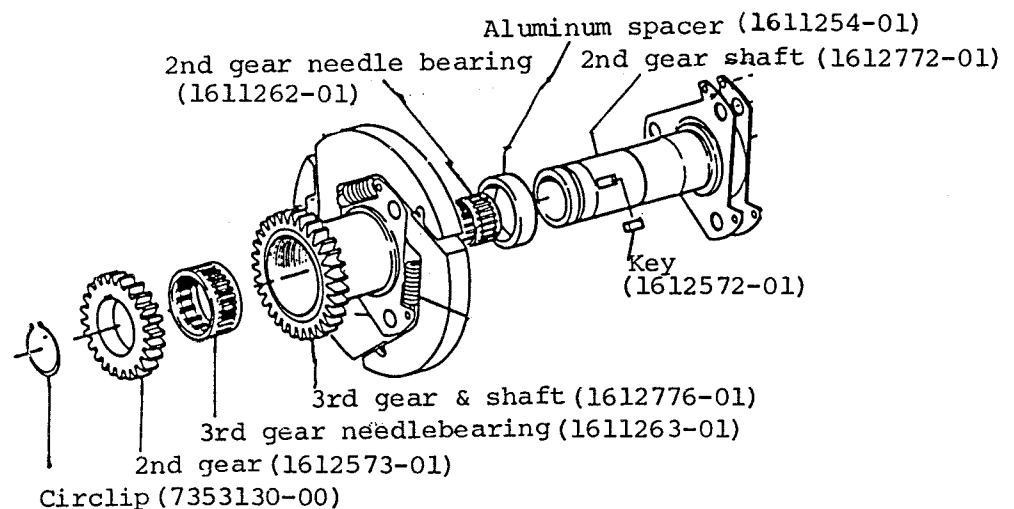
Once the second and third gear clutches are removed from the mainshaft and drum, you need to exercise extreme care in the disassembly of second and third gears. Please read and follow the directions for disassembly.

1. Remove the circlip that retains the aluminium spacer from the second gear shaft.
2. Remove the aluminium spacer from the second gear shaft.
3. Now when removing the pressed on second gear from the second gear shaft use extreme caution not to move third gear on the second gear shaft more than 1mm. If third gear moves more than 1mm. damage to the third gear shaft and supporting needle bearing will result. We recommend a pair of sharp tire irons to pry second gear off the second gear shaft.
4. Once second gear is removed from the second gear shaft use a pair of pliers to remove the key from the shaft.
5. After removing the key you may then lift third gear cluster from the second gear shaft.

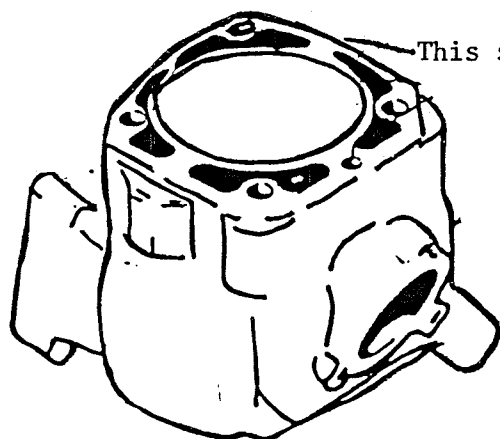
To avoid this problem the factory has added a machining process after the cylinder liner has been installed to surface the top of the cylinder.

This surface machined after assembly

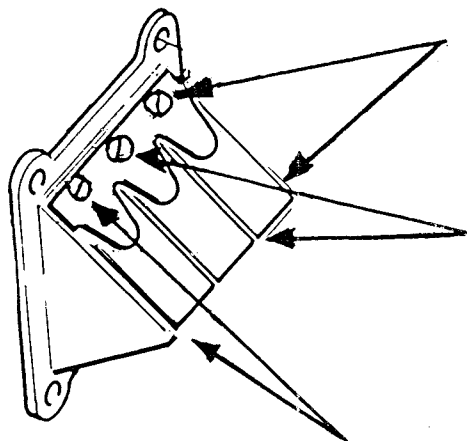
Check that these screw heads on top and bottom of valve holder do not rest on cylinder casting and prevent valve holder to seat itself on the cylinder casting.

- A. Remove the carburetor.
- B. Remove the intake manifold and gasket.
- C. Press the valve holder against the cylinder and check for the screw heads preventing the valve holder to seat flush against the cylinder casting.
- D. If the screw heads prevent the valve holder from seating flush against the cylinder casting; grind reliefs in the cylinder casting until the valve holder fits flush against the cylinder casting.
